Re: Geotechnical Exploration Report | Project No. 16060424  
City of Tulsa Street Rehabilitation Maintenance Zone (MZ) 1072 | 2036N1072Z, 2036B0216Z  
Various, Tulsa, OK

# BORING LOCATION PLAN

## PAVEMENT CORE ILLUSTRATIONS

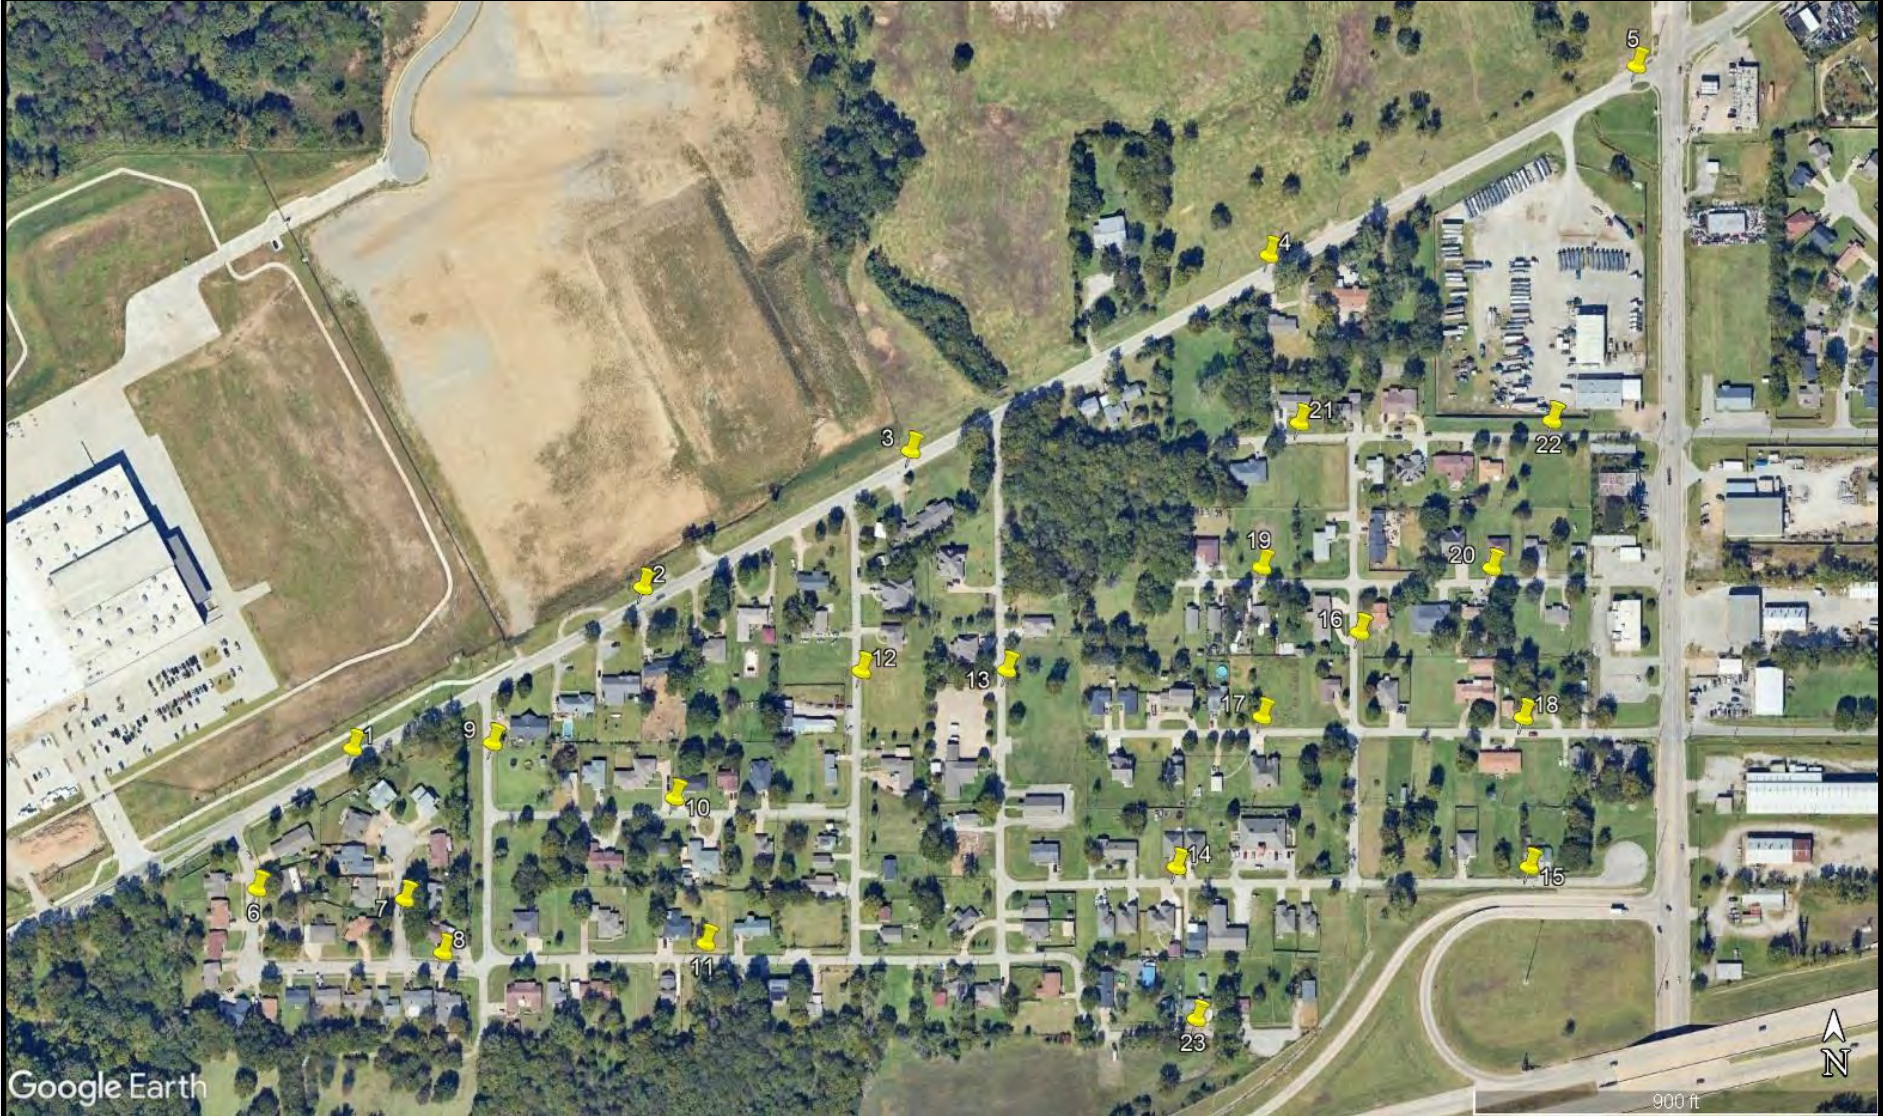
APPROXIMATE BORING LOCATIONS

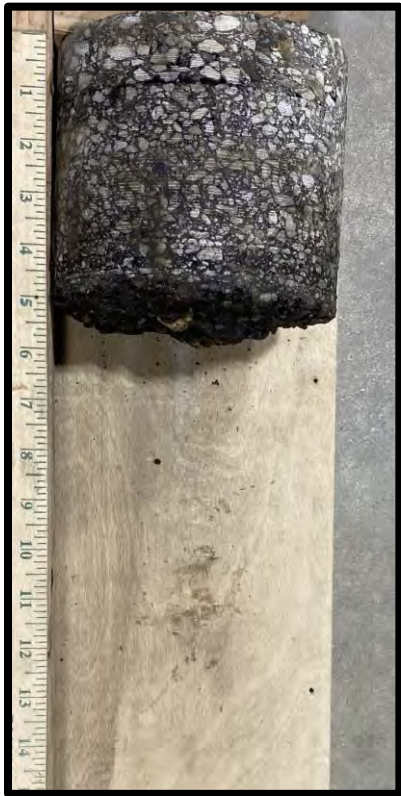
**B-1**

Location	Existing Asphalt Depth (in)	Existing Aggregate Base Depth (in)	Soil Test Boring Data		General Soil Strength Consistency	General Soil Color	General Soil Description	Unified Soil Classification System Group Symbol	In-place Moisture Content (%)	Finer than No. 200 Sieve (%)	Atterberg Limits		
			Depth (ft)	SPT N-Value							Liquid Limit (%)	Plastic Limit (%)	Plasticity Index
B-1	5.49	N/A	0 to 1.5	9	stiff	light & medium grayish brown	sandy lean clay	CL	21.9	50.8	39	19	20

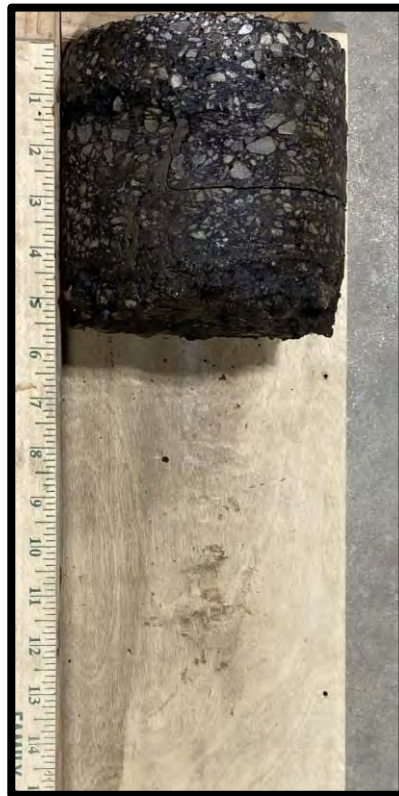
**B-2**

1.5 to 3	74	hard	light & medium grayish brown	lean clay						
B-2	5.63	2.00	0 to 1.5	8	stiff	dark brown	lean clay w/ sand	CL	20.8	76.8	42	20	22
			1.5 to 3	28	very stiff	light grayish brown	lean clay						
B-3	4.69	2.00	0 to 1.5	79	very hard	medium grayish brown	sandy lean clay	CL	14.3	62.7	29	21	8

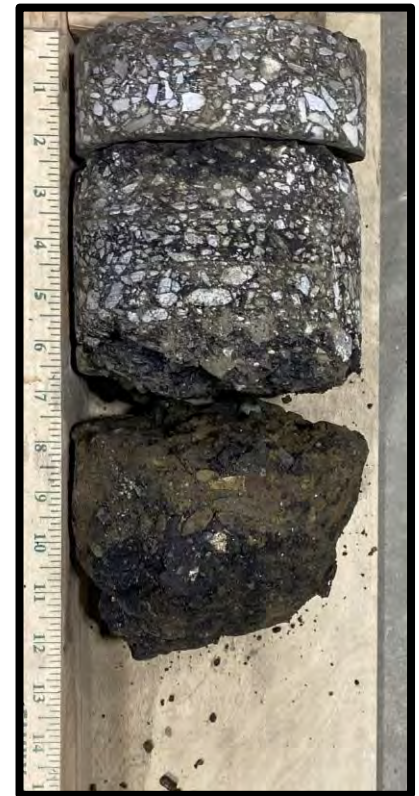
**B-4**

1.5 to 3	50/5.5	soft	light grayish brown	shale w/ sandstone fragments						
B-4	12.26	N/A	0 to 1.5	7	stiff	dark brown	sandy lean clay	CL	23.3	66.9	32	21	11

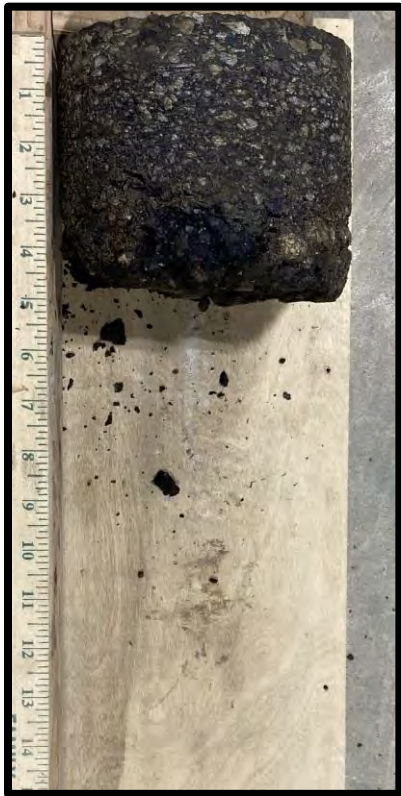
**B-5**

1.5 to 3	7	stiff	dark brown	sandy lean clay						
B-5	4.85	N/A	0 to 1.5	9	stiff	dark brown	sandy lean clay	CL	20.1	65.8	29	20	9
			1.5 to 3	50/5.0	soft	medium grayish brown	shale w/ sandstone fragments						
B-6	9.24	N/A	0 to 1.5	26	very stiff	light grayish brown	lean clay	CL	15.7	86.0	30	20	10

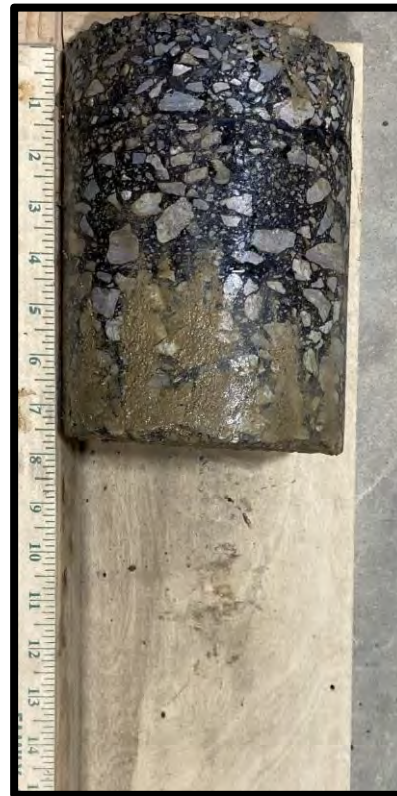
**B-7**

1.5 to 3	53	hard	light grayish brown	lean clay						
B-7	7.80	N/A	0 to 1.5	37	hard	medium grayish brown	sandy silty clay	CL-ML	19.1	58.6	27	22	5
			1.5 to 3	50/3.0	poorly cemented	medium grayish brown	sandstone w/ shale fragments						
B-8	8.40	2.00	0 to 1.5	33	hard	dark & medium grayish brown	sandy silty clay	CL-ML	17.9	67.9	28	21	7

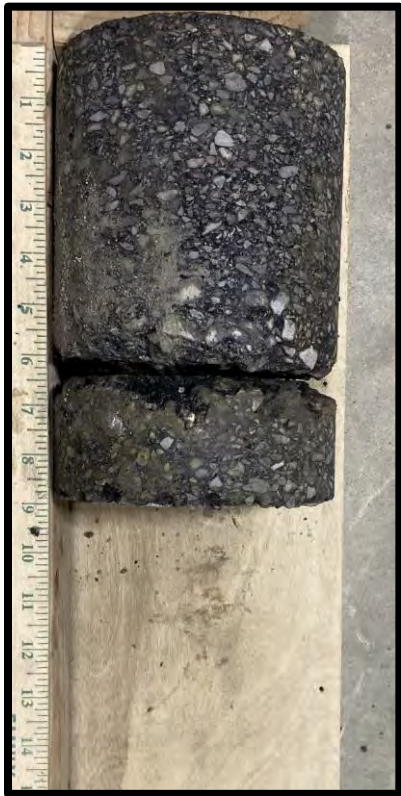
**B-9**

1.5 to 3	50/5.0	poorly cemented	medium & light grayish brown	sandstone w/ shale fragments						
B-9	8.93	4.00	0 to 1.5	20	medium dense	light grayish brown	aggregate base	ML	21.4	64.3	27	24	3

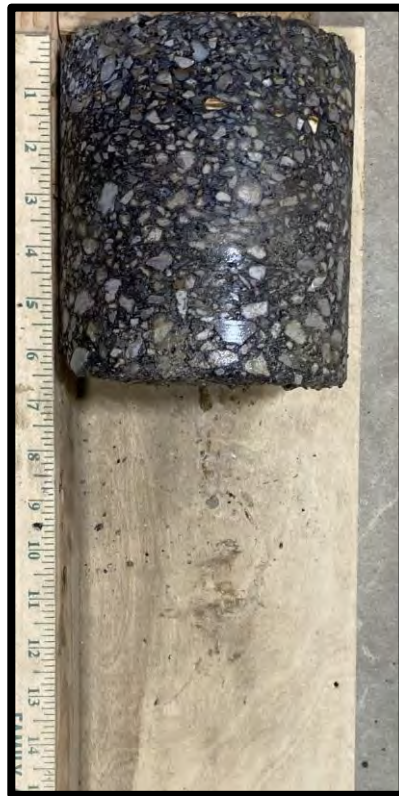
**B-10**

1.5 to 3	11	stiff	medium brown	sandy silt						
B-10	6.64	4.50	0 to 1.5	12	stiff	light gray	sandy silty clay	CL-ML	18.0	83.7	25	18	7
			1.5 to 3	11	stiff	medium brown	lean clay

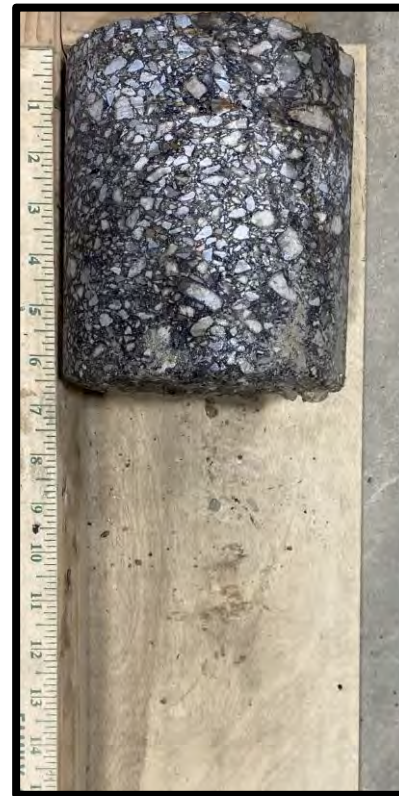
**B-11**

Location	Existing Asphalt Depth (in)	Existing Aggregate Base Depth (in)	Soil Test Boring Data		General Soil Strength Consistency	General Soil Color	General Soil Description	Unified Soil Classification System Group Symbol	In-place Moisture Content (%)	Finer than No. 200 Sieve (%)	Atterberg Limits		
			Depth (ft)	SPT N-Value							Liquid Limit (%)	Plastic Limit (%)	Plasticity Index
B-11	6.68	1.00	0 to 1.5	13	medium dense	light gray	aggregate base	SC-SMGC-GM	9.4	19.7	17	11	6

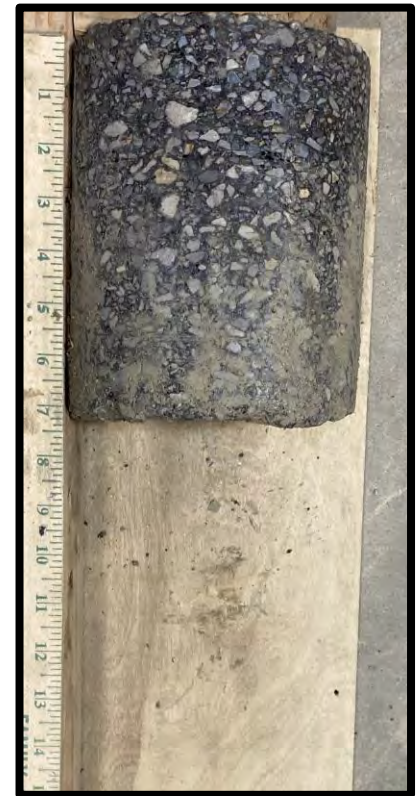
**B-12**

1.5 to 3	2	very loose	light gray	aggregate base						
B-12	7.24	5.00	0 to 1.5	25	medium dense	light gray	aggregate base	CL-ML	20.1	65.7	26	19	7
			1.5 to 3	12	stiff	medium & light grayish brown	sandy silty clay						
B-13	6.39	N/A	0 to 1.5	9	stiff	dark grayish brown	lean clay	CL			43	17	26

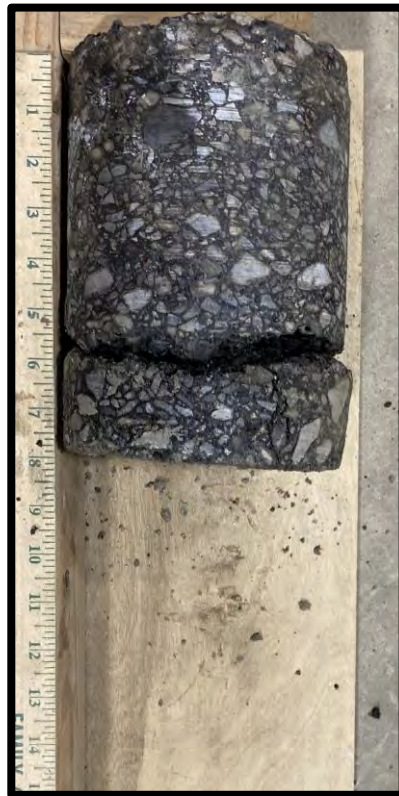
**B-14**

1.5 to 3	14. 50/5.5	poorly cemented	medium and light brown	sandstone						
B-14	8.10	4.50	0 to 1.5	5	medium stiff	dark grayish brown	lean to fat clay	CL			48	16	32

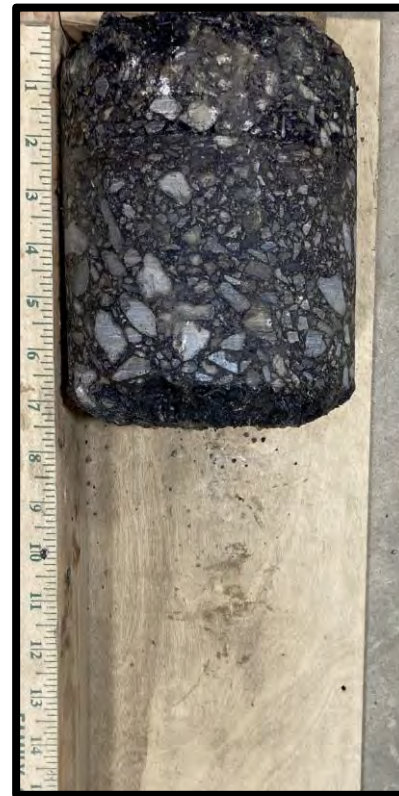
**B-15**

1.5 to 3	4	medium stiff	medium grayish brown	lean to fat clay						
B-15	7.46	5.50	0 to 1.5	7	stiff	dark grayish brown	lean clay	CL	20.9	96.8	35	18	17

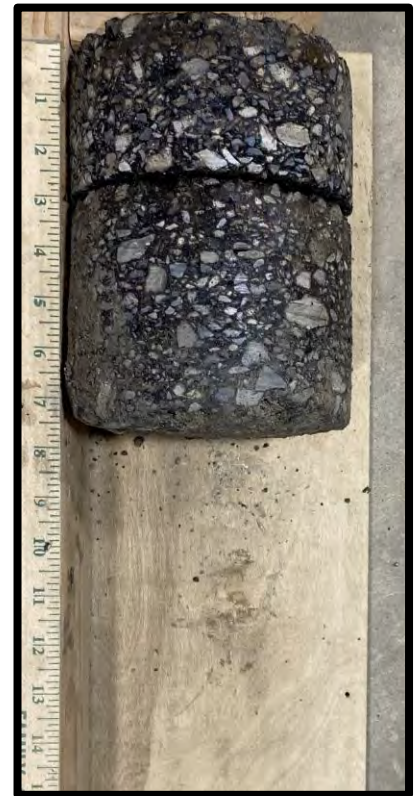
**B-16**

1.5 to 3	9	stiff	medium grayish brown	lean clay						
B-16	7.77	6.50	0 to 1.5	11	stiff	dark brown	lean to fat clay	CH	22.0	91.8	50	16	34
			1.5 to 3	5	medium stiff	medium grayish brown	fat clay						
B-17	7.58	6.00	0 to 1.5	10	stiff	dark grayish brown	lean clay	CL	23.9	91.2	39	15	24

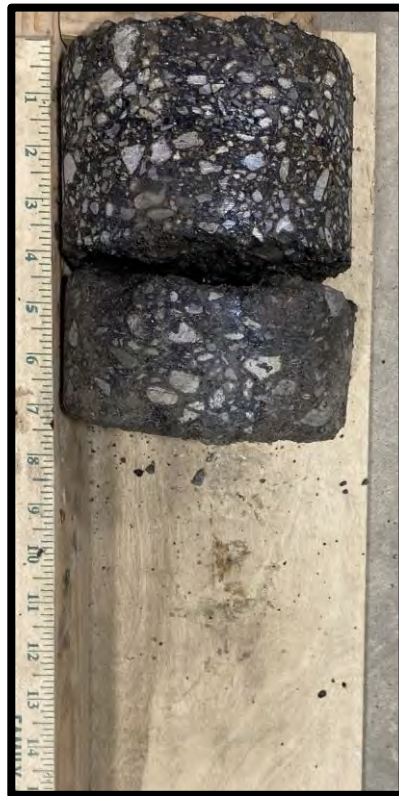
**B-18**

1.5 to 3	11	stiff	medium grayish brown	lean clay						
B-18	7.57	4.50	0 to 1.5	14	medium dense	light gray	aggregate base	CH	21.7	91.6	54	14	40
			1.5 to 3	13	medium dense	medium grayish brown	fat clay						
B-19	6.86	8.00	0 to 1.5	9	stiff	dark grayish brown	fat clay	CH	22.6	80.1	54	16	38

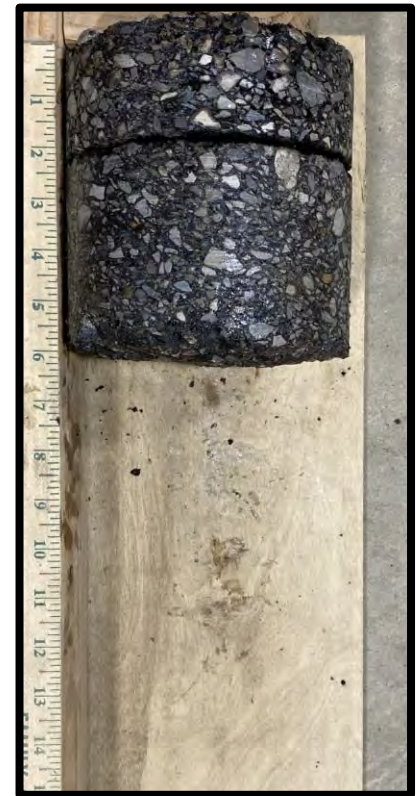
**B-20**

1.5 to 3	5	medium stiff	medium grayish brown	lean to fat clay						
B-20	6.20	4.00	0 to 1.5	9	stiff	dark grayish brown	lean clay	CL	21.7	92.1	35	15	20
